DDASaccident327

Humanitarian Demining Accident and Incident Database
AID

DDAS Accident Report

Report date: 15/03/2004	Accident number: 327
Accident time: 10:43	Accident Date: 18/09/2000
Where it occurred: Morina village, MNB West, VJ MF 3501	Country: Kosovo
Primary cause: Field control inadequacy (?)	Secondary cause: Inadequate training (?)
Class: Excavation accident	Date of main report: 18/04/2001
ID original source: MD/EW/LH/JF	Name of source: KMACC
Organisation: Name removed	
Mine/device: PMA-2 AP blast	Ground condition: bushes/scrub grass/grazing area
Date record created: 20/02/2004	Date last modified: 20/02/2004
No of victims: 1	No of documents: 3

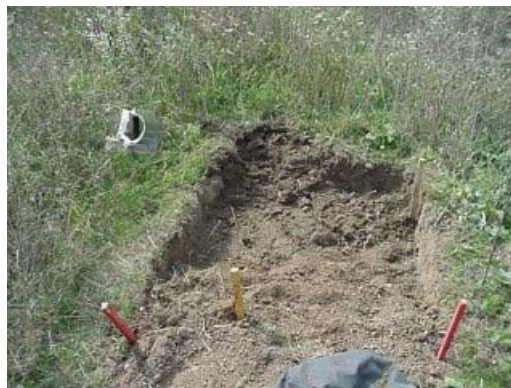
The picture above shows the visor and blast "crater".

There is dust/debris blown into the inside of the visor. Pitting/dust is present towards the base of the visor on the inside. Indicating either the visor has been worn incorrectly, the deminer was almost over the top of the mine when it detonated or the deminer was looking up and away from the mine when it detonated. The first of these options is the most likely, possibly combined with the third.

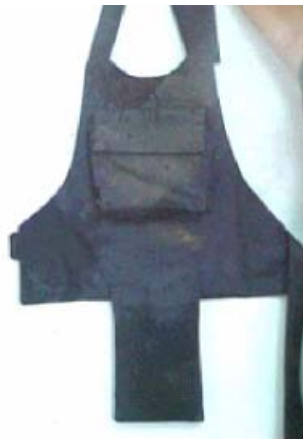
16. At the time of the accident [the Victim] was wearing the proper uniform and personnel protective equipment (PPE) according to the [Demining group] SOPs. However the facial and eyes injuries indicate that the visor was worn incorrectly and that the deminer was almost over the top of the mine when it detonated. According to the [Demining group] the full-face visor they use is designed to withstand the effects of blast and fragmentation mine at close range. The Body Armour used by [Demining group] is a lightweight, one piece, protective vest that is designed to withstand the effects of low velocity ballistic fragmentation at very close ranges. Even if the equipment is worn properly there is always a small gap between the Body Armour and the bottom part of the visor.

[Pictures of the victim are in the Medical report. The picture above shows the Victim's minimal frontal body protection with no collar to interface with the visor.]

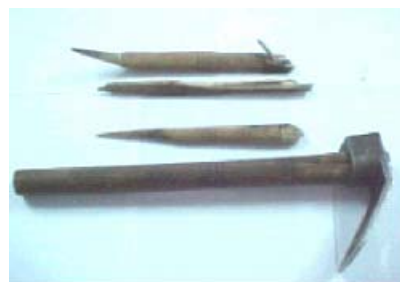
17. The equipment used by [the Victim] at the time of the accident was the appropriate equipment issued by [Demining group] for the sapping drill [metal-detectors were apparently not in use.]. The metal front part of the sapping tool has not been found yet.

The picture above shows the recovered parts of the sapping tool (shards of wood) and a complete tool showing the missing metal head.

Initial impression at the site and from the injuries suffered and damage to equipment, is that the deminer was working in a half-kneeling position excavating with his hand tool in a scraping motion across the face of the lane. The hand tool disintegrated and pieces of the handle have been recovered. The metal head of the tool has not been located at this time.

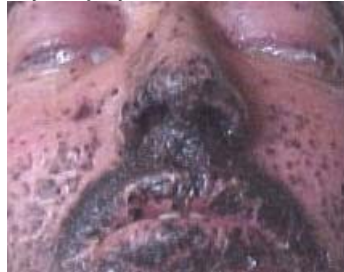
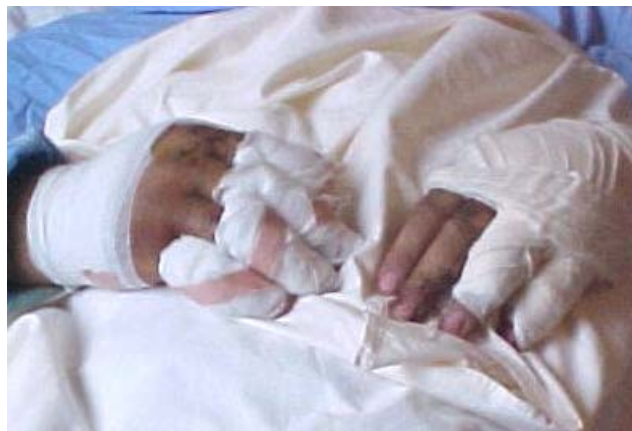
A left shoulder injury was noted by the Section Commander who rescued the Victim from the minefield – see Statements. The Victim's face and hands were photographed in hospital. [It is hard to understand why possible eye injury was not noted on the site.]
